# BULLETIN

## *PRODUCT SERVICES - Schaumburg*

Subject: MSR2000 and MSF5000 Ferro Resonant power supplies,  
TPN1185A, TPN1218A, TPN1184A, TPN1192A, TPN1226A, TPN1227A

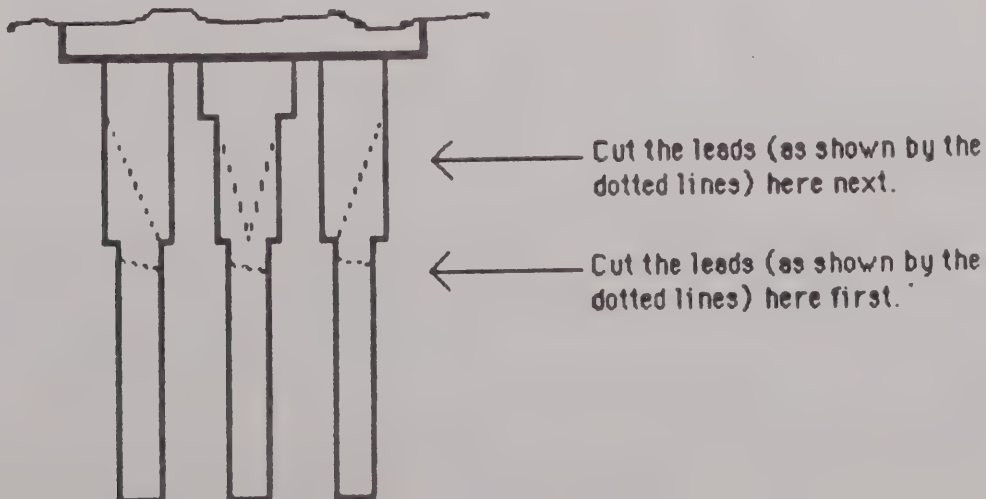
Due to the failures of the 51-83629M44 18 volt regulator, we are cancelling PSD 545 and recommending that all regulators with a date code of QQ8401 or later (see Fig 2) be replaced with the T.I. part-under the same Motorola part No.

Due to recent packaging changes on the 51-83629M44-18-V voltage regulator, replacement voltage regulators may not be mechanically compatible with the mounting available on the frame. This is the case when the area on the frame to which the I.C. is mounted contains only a circular hole and not a slot for the screw to pass through. Also, a new insulating shoulder washer is required (Motorola P/N 04-84180C01 replaces 0410057A13). There are simple modifications to be made to the leads of the integrated circuit. The only tool required is a sharp pair of small side cutters. Cut the leads as diagrammed below.

These modifications allow the regulator body to mount closer to the printed circuit board. Before soldering the leads into place, mount the regulator to the frame with the mica insulator, nut, bolt, and new insulating washer. This will insure the correct mounting height.

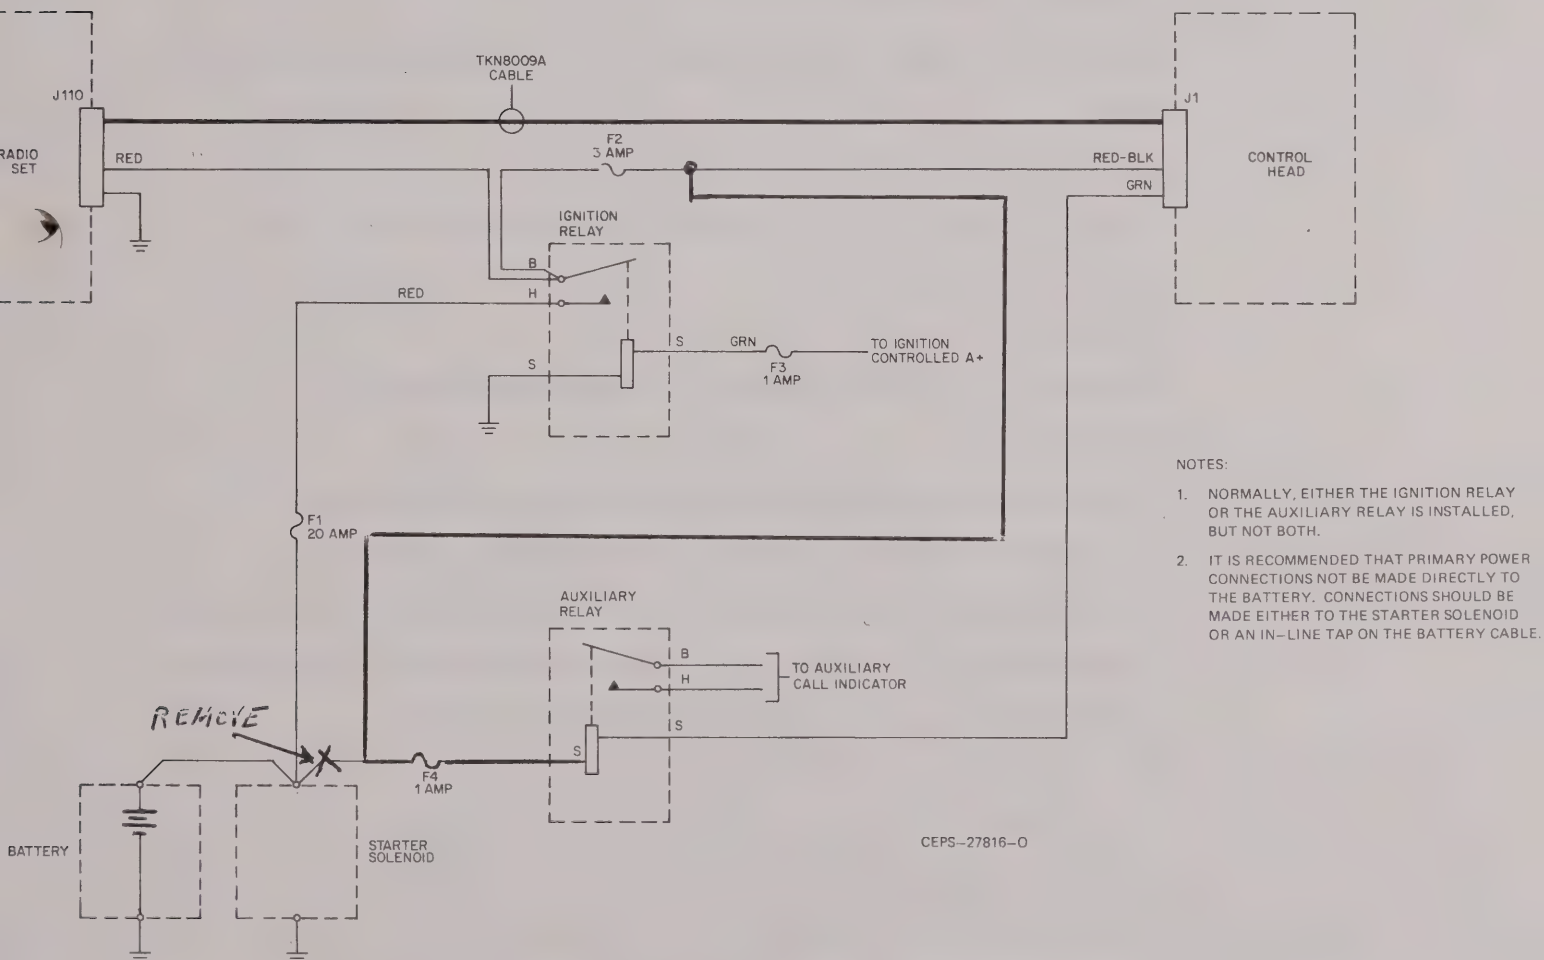
Figure V-1. Interconnect Diagram

1. Connecting the Auxiliary Relay Coil directly to the battery will result in the Auxiliary Alarm being activated continuously if the Cable Kit 3 amp fuse blows open. The A+ side of the auxiliary Relay Coil should be spliced into the Cable Kit 3 amp power line on the radio side of the 3 amp fuse.
2. "PULSAR 100" service manuals, 68P81037E50 issues O, A, and B, have a diagram in the Installation section on page 9 that incorrectly shows interconnecting the Auxiliary Relay Coil. Issue C service manual shows the correct interconnect scheme.
3. Figure V-1 exhibits a corrected "Interconnect Diagram".

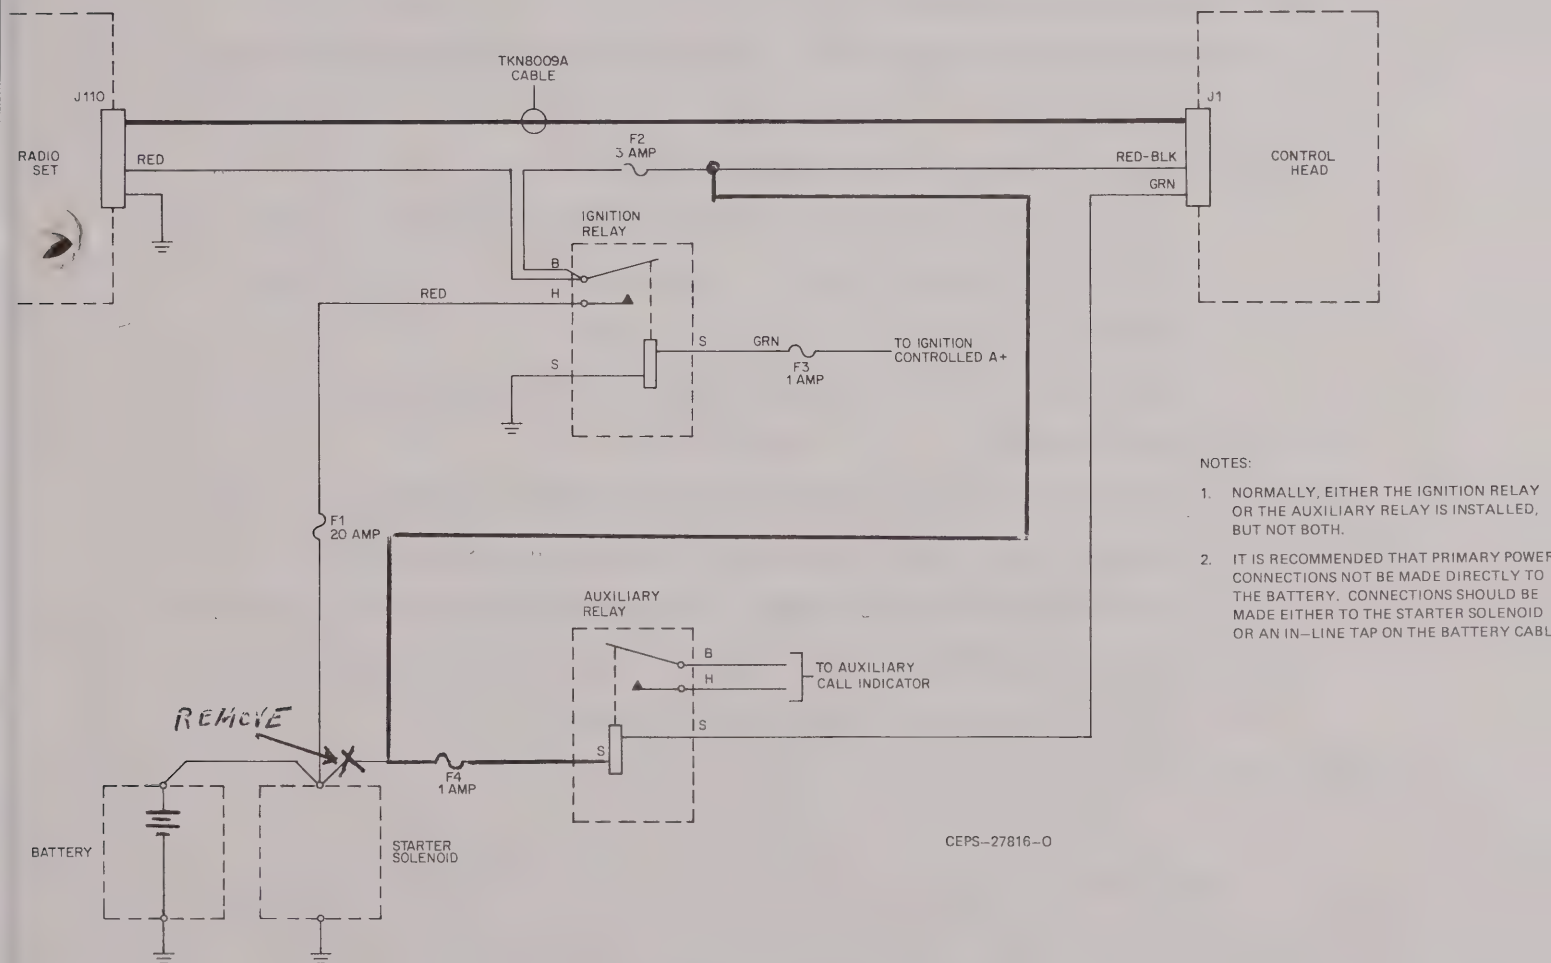
Figure V-1. Interconnect Diagram

1. Connecting the Auxiliary Relay Coil directly to the battery will result in the Auxiliary Alarm being activated continuously if the Cable Kit 3 amp fuse blows open. The A+ side of the auxiliary Relay Coil should be spliced into the Cable Kit 3 amp power line on the radio side of the 3 amp fuse.
2. "PULSAR 100" service manuals, 68P81037E50 issues O, A, and B, have a diagram in the Installation section on page 9 that incorrectly shows interconnecting the Auxiliary Relay Coil. Issue C service manual shows the correct interconnect scheme.
3. Figure V-1 exhibits a corrected "Interconnect Diagram".
